Manhole Inspection Summary

Manhole # S290__022MH

Insp Date: **4/13/09 3:07 PM**

Location Address: **1111 W WEST ST**

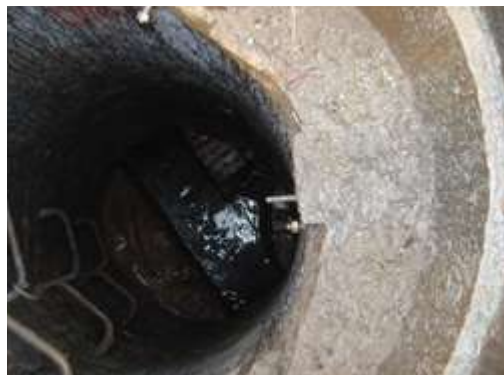
Defect 4

Offset: **5** (in.)

5 INCH OFFSET

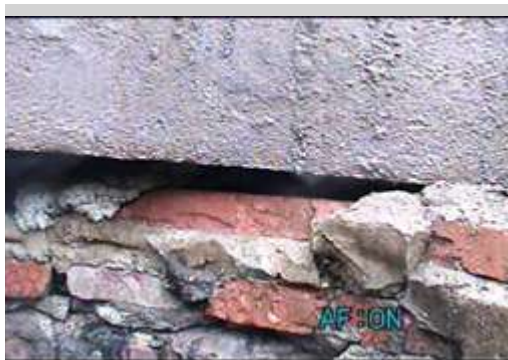
Defect 3

Condition: ☐ Sound ☐ Cracked ☐ Root Intrusion ☐ Loose Brick ☒ **Deteriorated**

DETERIORATED CHIMNEY

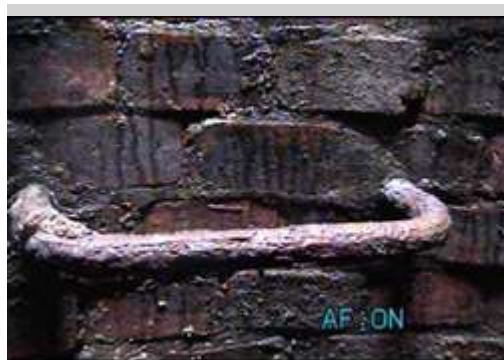
Defect 2

Count: **7** Missing: **0** ☒ **Corroded**

CORRODED RUNG

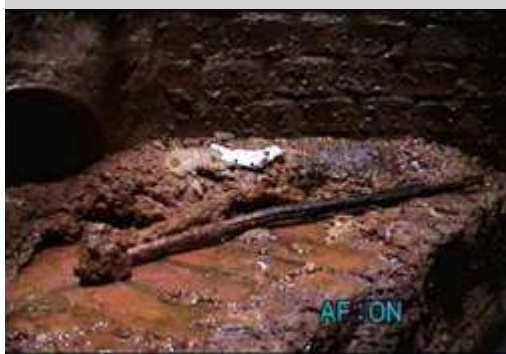
Defect 1

Condition: ☐ Sound ☐ Cracked ☐ Root Intrusion ☐ Deteriorated ☐ Leaks ☒ **Debris**

DEBRIS ON BENCH

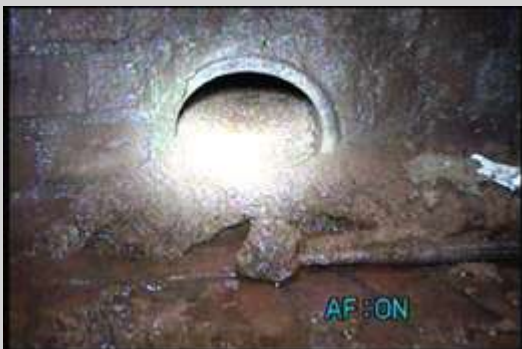
3 O'Clock Inflow

Pipe Height: **8.4** (in.) Rod and Bar (Angled)
Pipe Material: **Clay** ☐ Pipe Lined
Invert Depth: **11.27** (ft.) Flow Characteristics: **None**
Deposits: ☐ None ☐ Mud ☒ **Sludge** ☐ Debris ☐ Grease
Silt Depth: **3** (in.) Deposits Extent: **Medium**
Infiltration: **None** Pipe Seal Cond: **Sound**

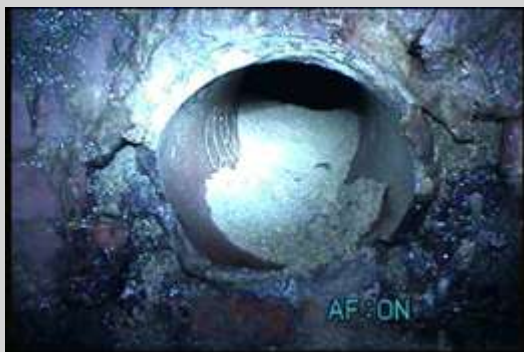
9 O'Clock Inflow

Deposits: ☐ None ☒ Mud ☒ Sludge ☐ Debris ☐ Grease

Silt Depth: **3** (in.) Deposits Extent: **Medium**

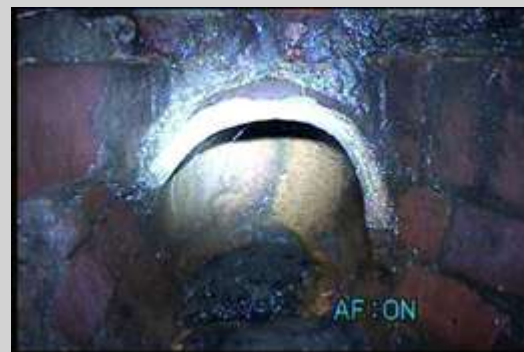
Drop In @ 9 O'Clock

Drop: **Outside** Rod and Bar
Angled: **Yes** Reading: **11.00** (ft.)
Inv Depth: **12.00** (ft.)

Drop Condition: **Partly Clogged**
